State of California - The Resources Agency
DEPARTMENT OF PARKS AND RECREATION
Office of Historic Preservation
Historic Resources Inventory

1. Historic name Ryland Block

*2. Common name or current name Security Building

*3. Number & street 74-86 S. First Street Cross-corridor _____

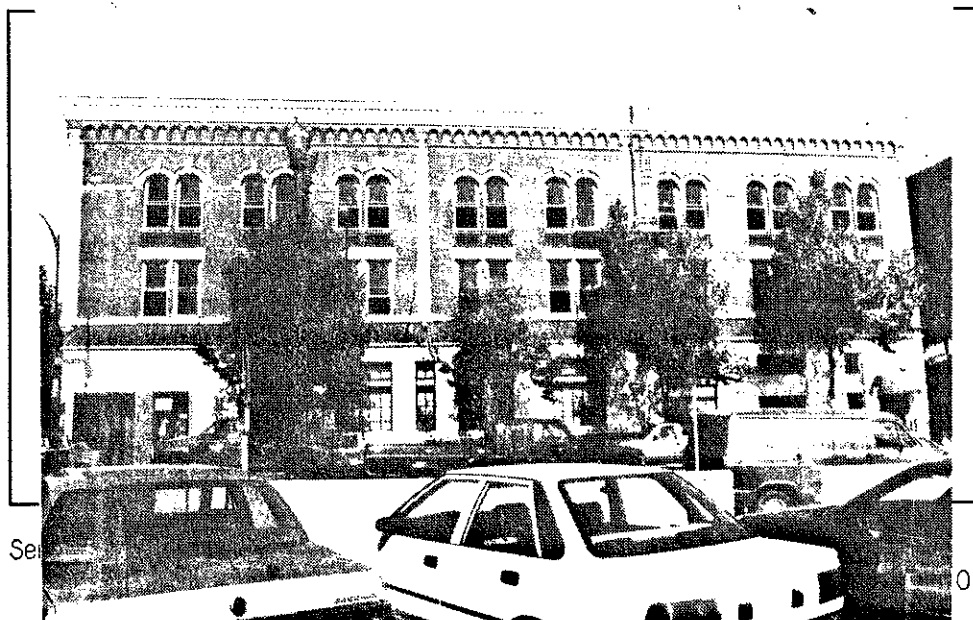
This three-story Romanesque brick building features sandstone detailing. The wide, flat arcaded cornice has a carved sandstone fascia. All the windows are arranged in pairs. The third story windows feature sandstone arches with prominent keystones joined by a rusticated sandstone impost course. The rectangular second story windows have continuous plain sandstone lintels. The recessed sprandels between the upper story windows have a textured brick pattern. The face of the building is divided in thirds by pilasters that rest on a rusticated sandstone belt course. The ground floor storefronts have been extensively remodeled. The building has an interior air/light well, some original ceilings, fancy metal stairs with extensive decorations, and a third floor gallery that connects to the adjacent Letitia Building.

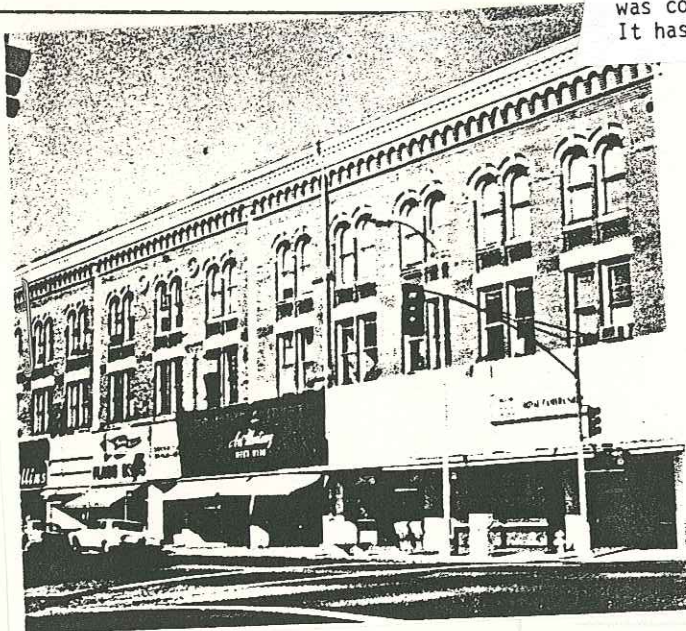
8. Ryland Block, 84 S. 1st STREET--A three-story Victorian Romanesque brick building, this was constructed by financier C.T. Ryland in 1892. It has been extensively remodelled.
